# **Technical Bulletin**

**BULLETIN NO. 20606**

DATE:	February 6, 2006		
PRODUCT:	SW Series		
FROM:	<b>Technical Service Department</b>		
TITLE:	Vent Proving Pressure Switch

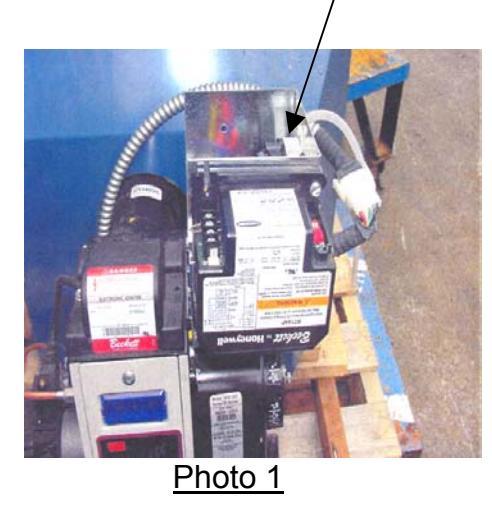
#### Vent Pressure Switch,

To detect a blocked vent condition on the SW series of boilers, a pressure switch has been incorporated into the boiler design to monitor the differential pressure between the intake air pipe and the flue exhaust (see photo 1). In the event the flow of air through or out of the boiler is reduced to unacceptable levels, the reduced air -flow will be detected by the pressure switch and render the boiler inoperable.

Effective immediately, all SW boilers being built will incorporate the blocked vent pressure switch.

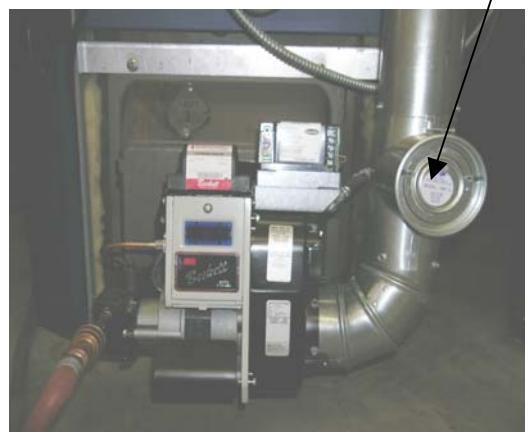
Photo 2

The Vacuum Relief Valve of the SW Series Utica Boilers (see photo 2) will be eliminated and replaced with an air proving pressure switch (see photo 1). This change creates a sealed combustion system that eliminates the need for indoor combustion air.

# Vacuum Relief Valve Is Eliminated

NOTE: Due to the addition of the pressure switch and its ability to detect air-flow, the vacuum relief valve (see photo 2) is no longer necessary and will be eliminated from the boiler design. The SW boiler will now utilize an intake collar with pressure switch tap (see photo 3)

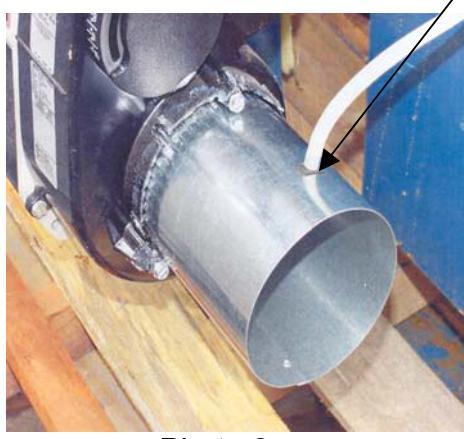
Photo 3

Intake Collar With Pressure Tap /

# (Used in place of the Vacuum Relief Valve)

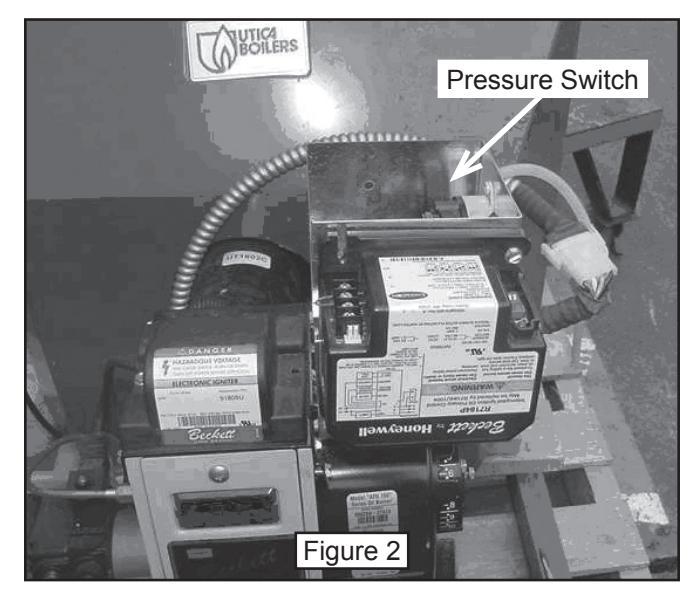
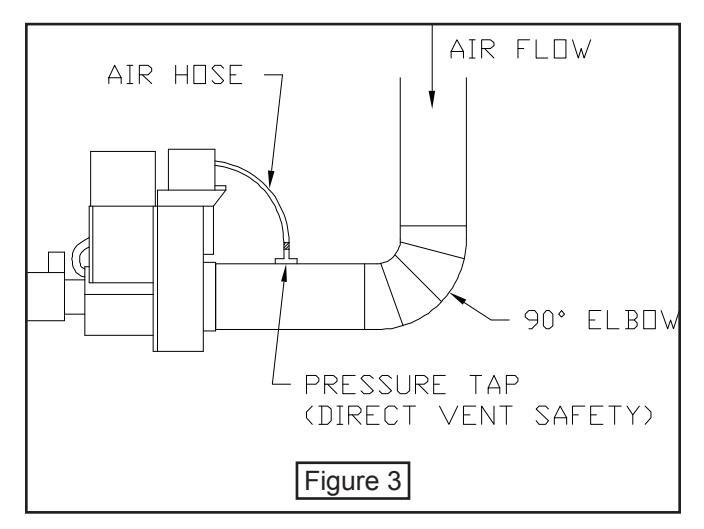
The direct vent safety system consists of a pressure switch that is mounted in a junction box on top of the oil burner. The pressure switch monitors the differential pressure between the exhaust gases measured at the flue adapter and the inlet air measured at the air inlet of the burner. (*Figures 2 & 3*)

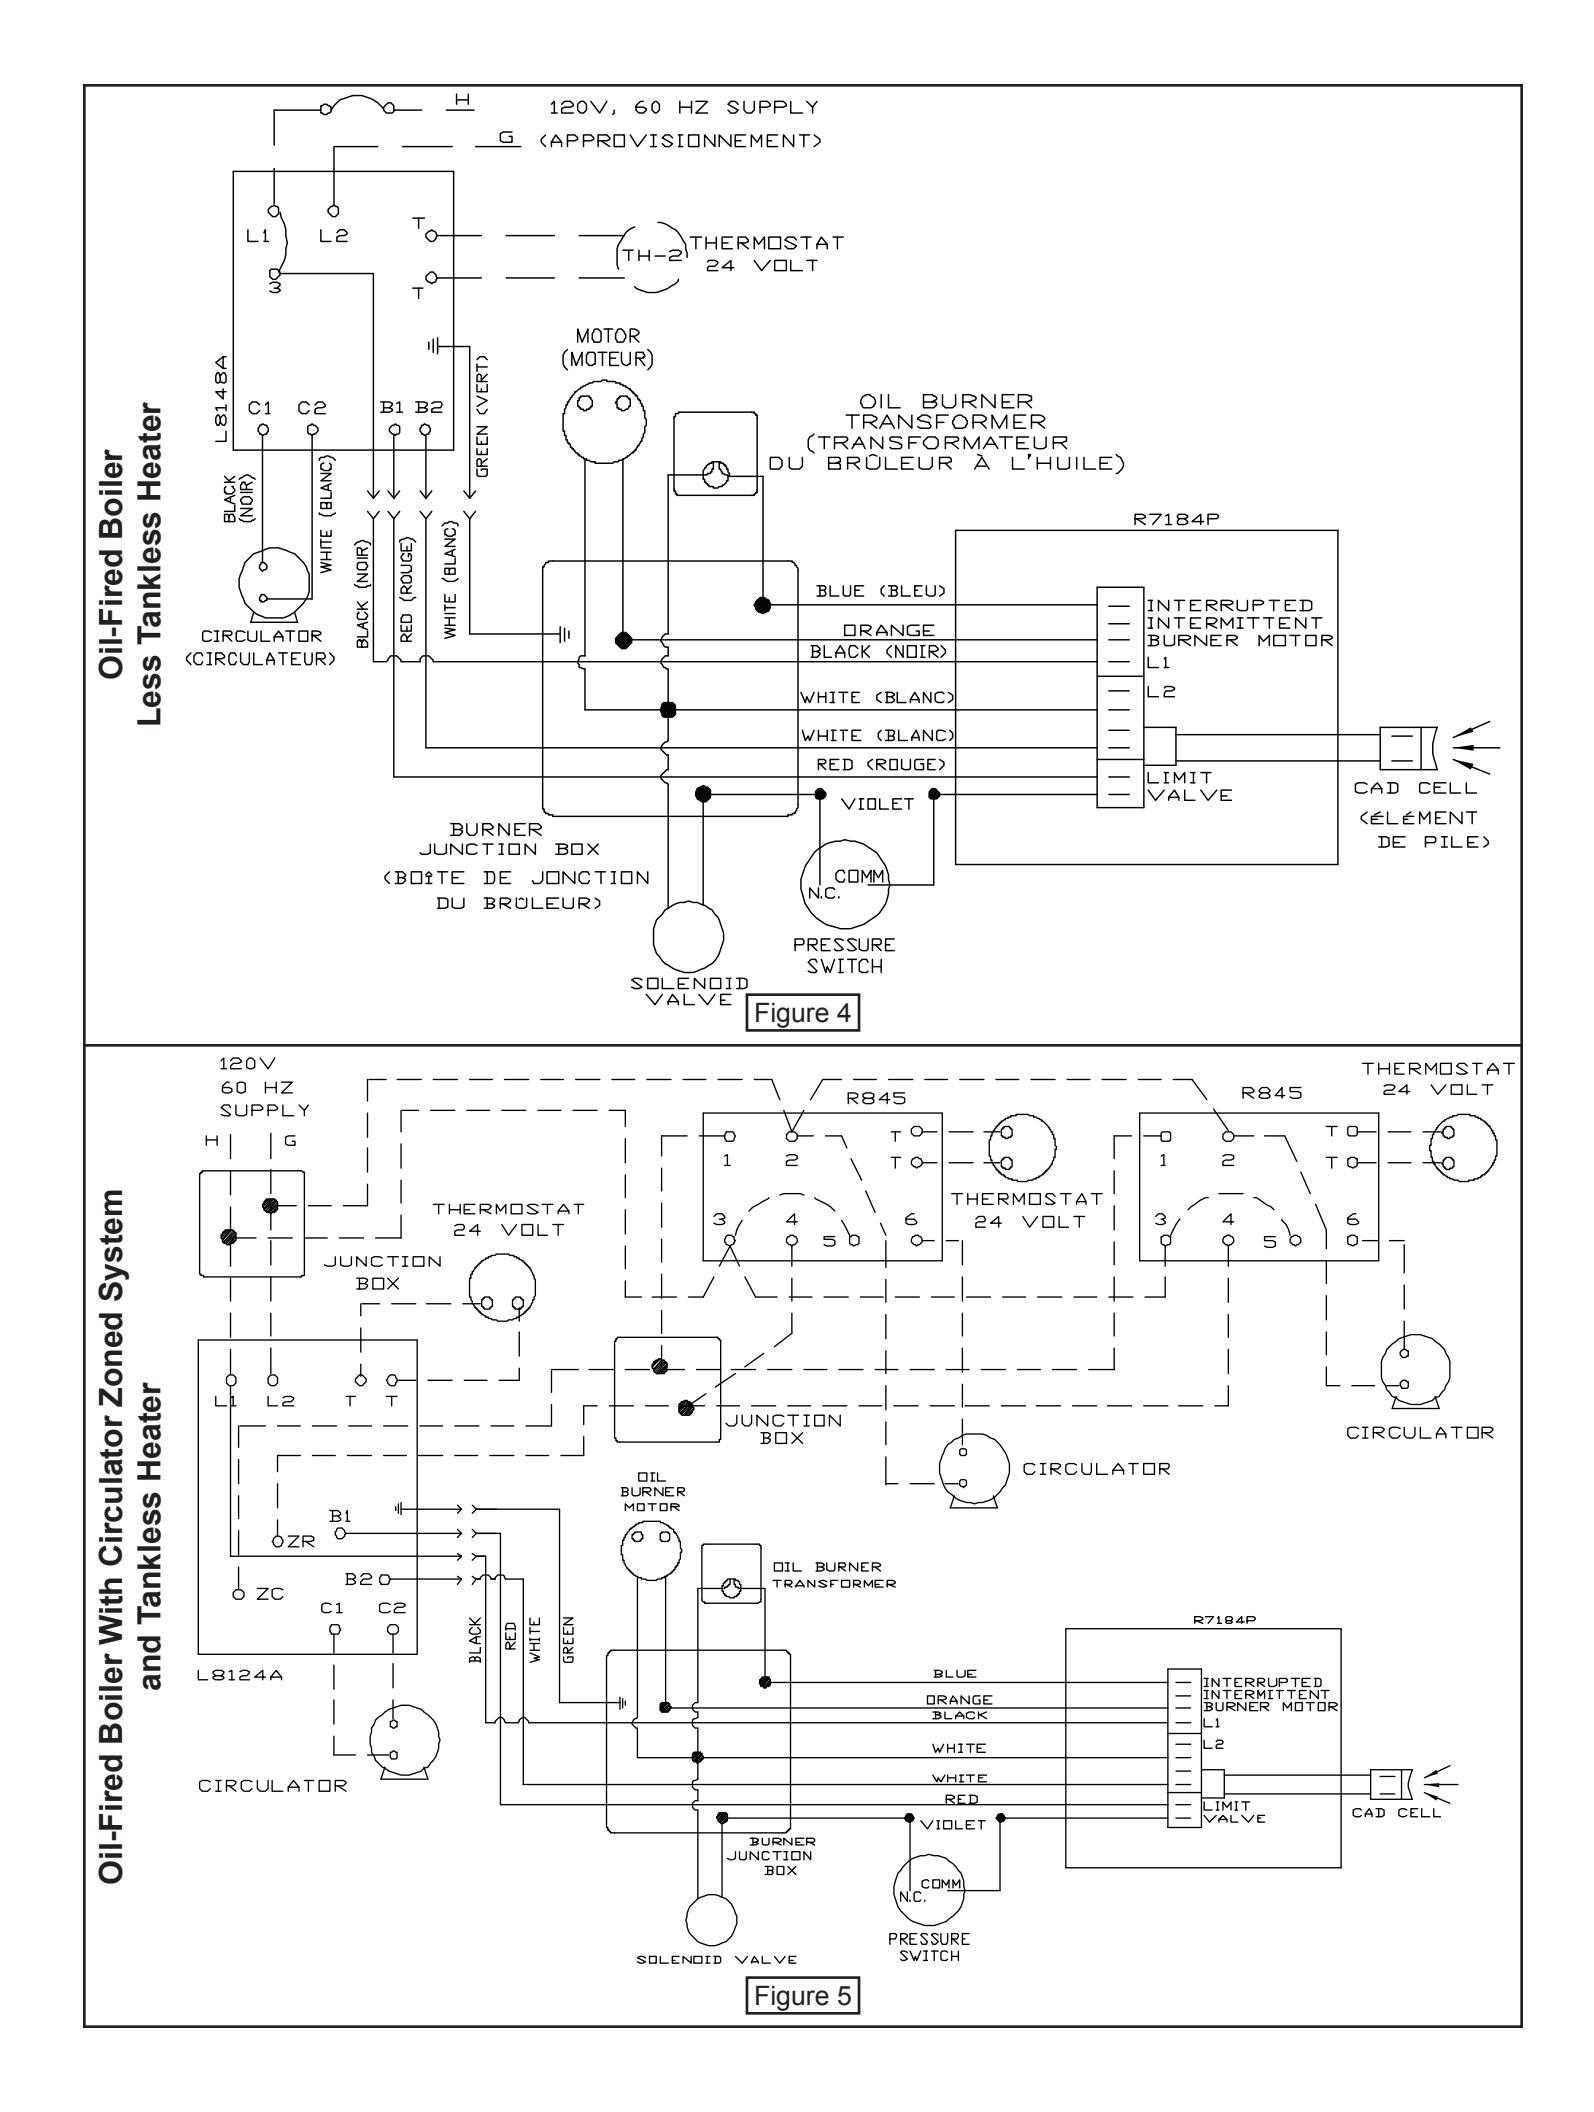
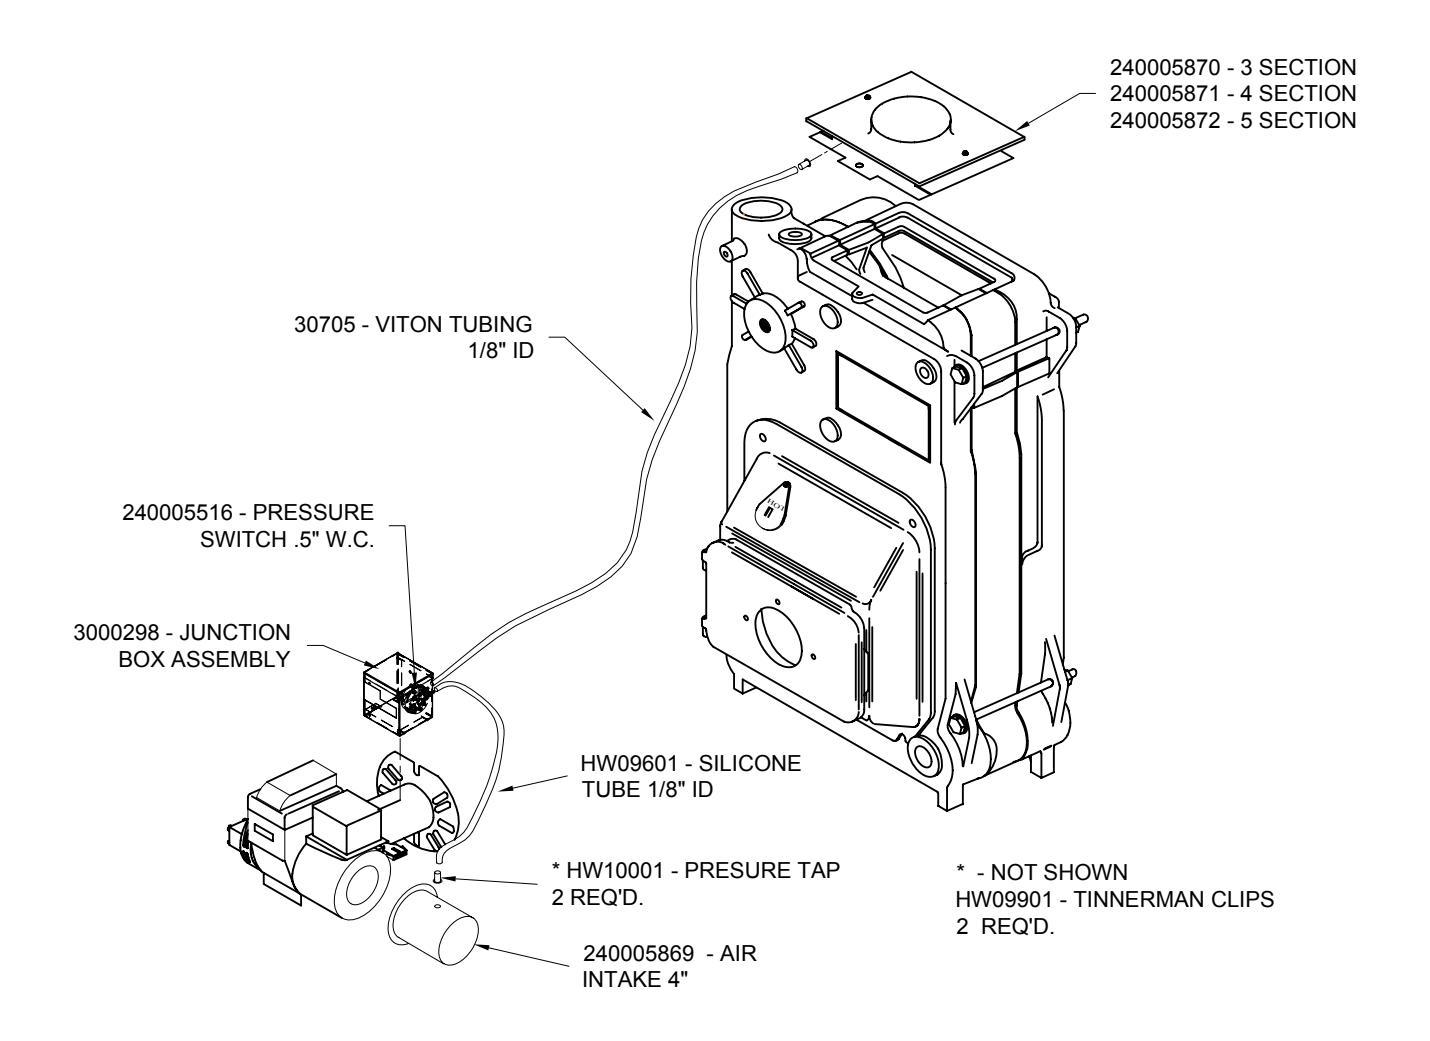
In the event that the differential pressure drops below .5" w.c., the pressure switch will open and the burner solenoid will lose power and stop the flow of oil to the nozzle assembly. (*Figures 4 & 5 on next page.*)
